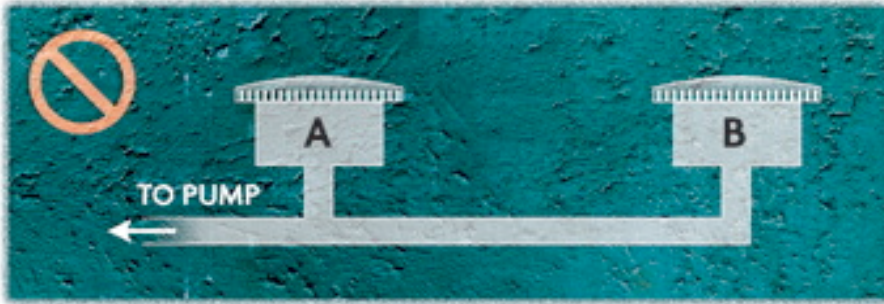
Illustration A: These drains have been placed in series, with the tee set under Drain A. The drains can't pull equally. Drain B is weaker. If Drain A were to become blocked, its counterpart may not be able to prevent a vacuum from forming.

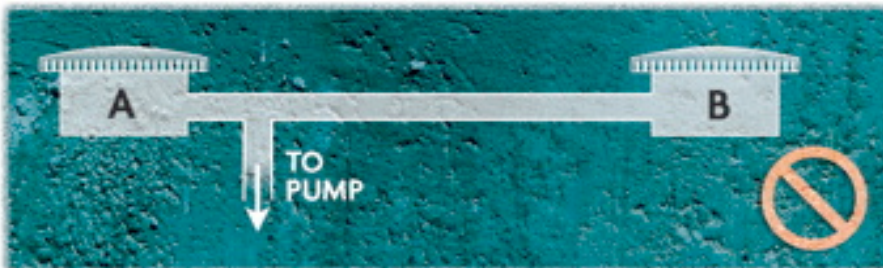
Illustration B: Here, the tee is set too close to Drain A and too far from Drain B. Again, Drain B becomes less effective.

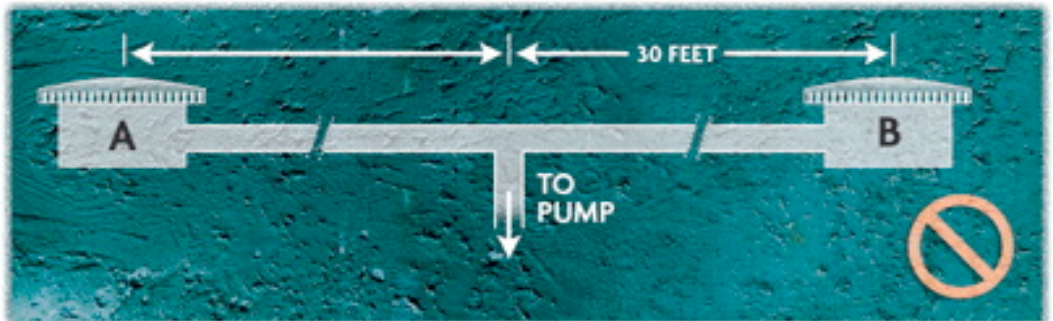
Illustration C: While the tee is correctly placed, both drains are set too far away from it. With too much distance between the tee and drain, you can't achieve proper flow. Studies are still determining how far is too far, but one expert recommends no more than 8 feet between the tee and drain.

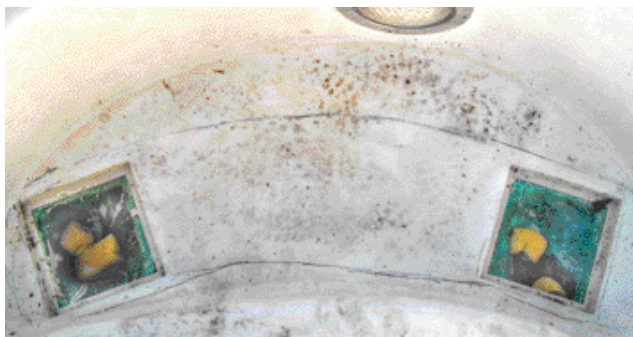
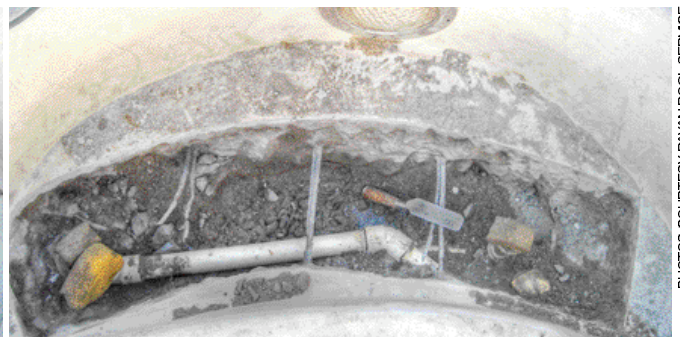
The big fake-out: At first, this system appeared legitimate, above left. Each drain had two pipes — one presumably connecting to the pump and the other to the skimmer equalization line. But when air was forced through the skimmer, bubbles only came out of one drain. Professionals cut the concrete to investigate, above right. But the drains ran separately. The two stub-ups with connecting pipe, opposite, led to nowhere, and seemed to be just for show.

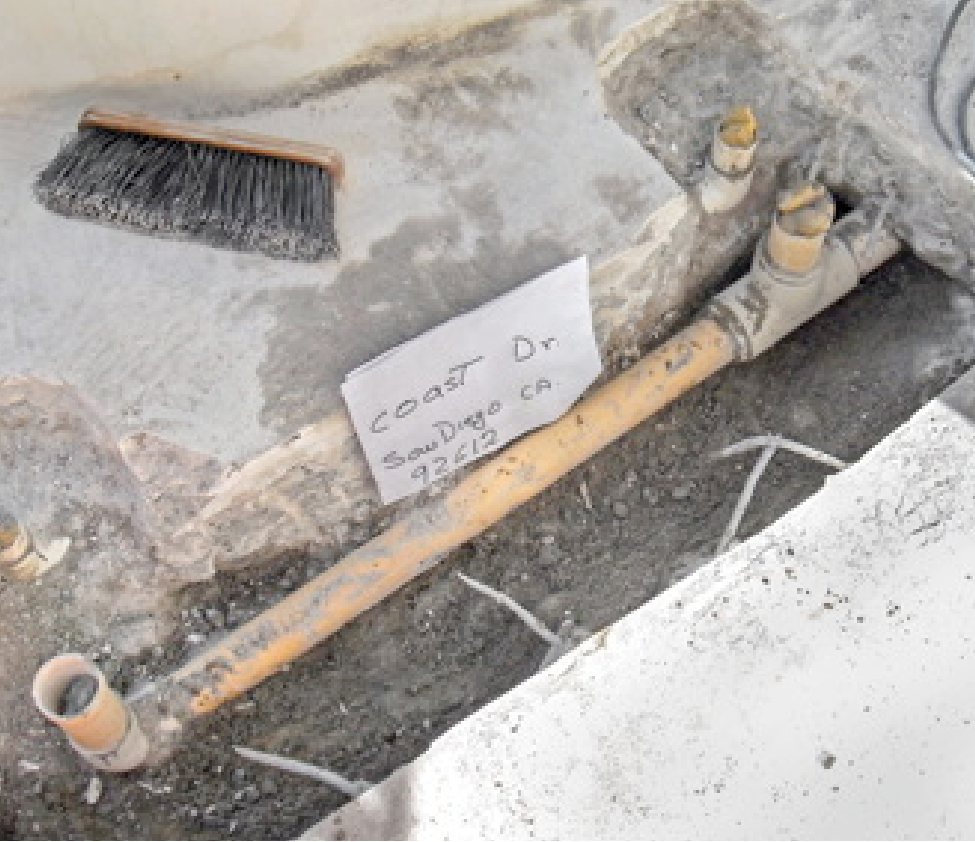
The right and wrong way: Service professional Javier Payan photographs each drain configuration he inspects, with the address included in the frame. In the top photo, the drains are not balanced, with the tee sitting below the right outlet. Cutting pipes on another site, middle, shows they are clogged with concrete, rendering one of the drains useless. At bottom, a properly re-plumbed dual-drain system, with the tee set in the middle.
